**Flood Control Project Maintenance
Levee Inspections**

Fall 2016 Levee Maintenance Deficiency Summary Report

Reclamation District No. 1500 Sutter Basin

Fall 2016 Levee Inspection Results

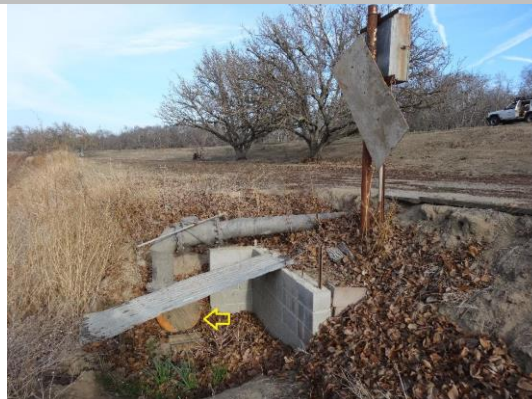
Photo 1 of 2 : UCIP_FA_2016_28183_51845.jpg

LM Start	0.31	Rating **	M	Issue No.	2583
LM End	0.31	Issue Type +	En	Location *	LS
Category	Supplemental			GPS Latitude/Longitude	
				Start	End
Item	DWR UCIP Field Study			38.763210 °	38.763210 °
				-121.679017 °	-121.679017 °
DWR ID					
Comment Code					
Inspector Comment					
FS_ID:28183 DS_ID:20032 EP_NO: 1566A Repair Type: Non-Urgent Crossing Status: Found UCIP Comments: - soil erosion around headwall on waterside.- pump was removed.- overhead powerline. FIELD_STRUCT_DESC: 10-inch steel irrigation pipe through levee, 5.0 feet below crown. Pump and switch panel on waterside berm. Service pole on waterward shoulder. Siphon breaker on landward slope. A 3-foot by 4-foot concrete distribution box at landward toe (App. No. 1566A White) O&M Manual Sac 128, March 1960. FS Date: 1/9/2014

WS view: concrete blocks headwall and pump on river bank. Pump has been removed (marked). Surface erosion around headwall.

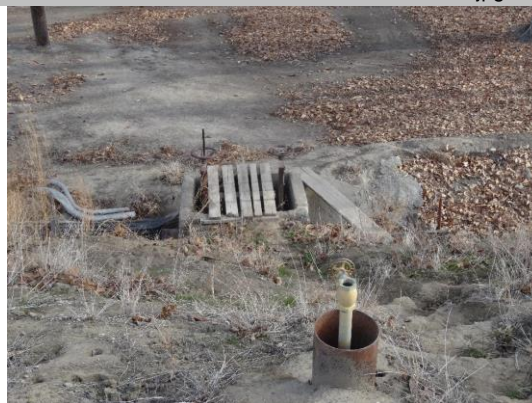
Photo 2 of 2 : UCIP_FA_2016_28183_51844.jpg

LS view: pressure breaker (bottom) in steel pipe riser and concrete distribution box on levee toe.

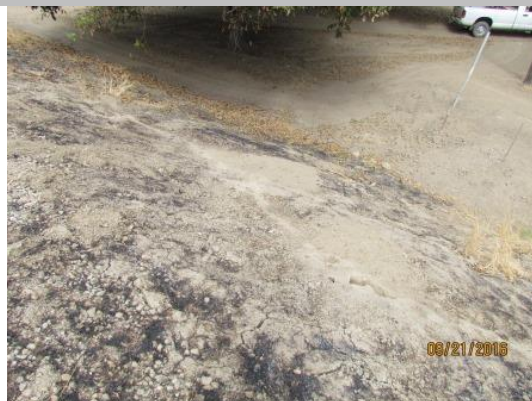
Photo 1 of 1 : FA_2016_RD1500_189_135_20160926_00272.jpg

LM Start	0.32	Rating **	M	Issue No.	135
LM End	0.32	Issue Type +	Ma	Location *	LS
Category	Earthen Levee			GPS Latitude/Longitude	
				Start	End
Item	Animal Control			38.763267 °	38.763267 °
				-121.679050 °	-121.679050 °
DWR ID	DWR_RD1500_01_f_2016_135				
Comment Code					
A3 : No rodents visible, but rodent burrows visible; need to backfill and compact or grout burrows.					
Inspector Comment

Rodent activity on LS slope. Fall 2016.

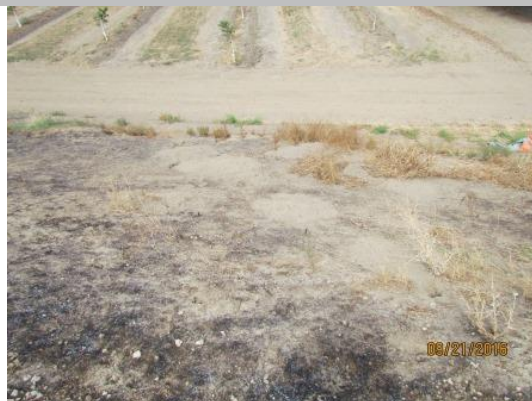
Photo 1 of 1 : FA_2016_RD1500_189_134_20160926_00271.jpg

LM Start	0.49	Rating **	M	Issue No.	134
LM End	0.49	Issue Type +	Ma	Location *	LS
Category	Earthen Levee			GPS Latitude/Longitude	
				Start	End
Item	Animal Control			38.764497 °	38.764497 °
				-121.681867 °	-121.681867 °
DWR ID	DWR_RD1500_01_f_2016_134				
Comment Code					
A3 : No rodents visible, but rodent burrows visible; need to backfill and compact or grout burrows.					
Inspector Comment

Rodent burrows on LS slope. Fall 2016.

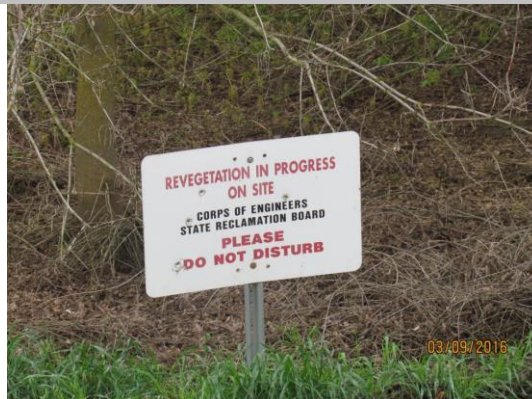
Photo 2 of 2 : FA_2016_RD1500_189_72_20160913_00045.jpg

LM Start	0.56	Rating **	A/W	Issue No.	72 (cont)	
LM End	0.82	Issue Type +	Ma	Location *	WS	
Category	Earthen Levee			GPS Latitude/Longitude		
				Start		End
Item	Vegetation			38.764462 °		38.764638 °
				-121.683167 °		-121.687690 °
DWR ID	DWR_RD1500_01_s_2012_72					
Comment Code						
V8 : Environmental Requirements.						
Inspector Comment

Sign is located at the toe of the levee on the waterward side. Spring 2016.

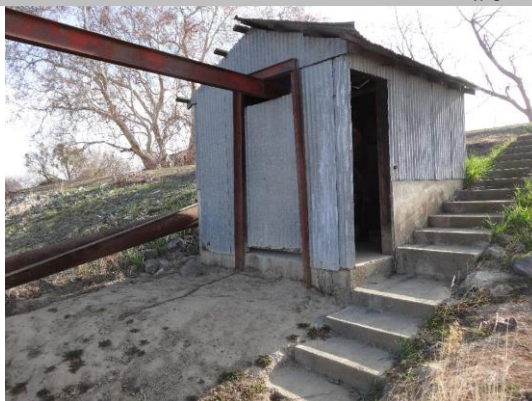
Photo 1 of 2 : UCIP_FA_2016_28903_53162.jpg

Comment Code						
Inspector Comment						
FS_ID:28903						
DS_ID:20094						
EP_NO: 10080						
Repair Type: Non-Urgent						
Crossing Status: Found						
UCIP Comments: Pump removed from concrete pad and kept inside pump house (may be for storage purpose) on waterside.A 8-inch steel pipe inside 14-inch pipe.						
FIELD_STRUCT_DESC: 14-inch steel irrigation pipe through levee, 5.2 feet below crown. Pump on river bank. Butterfly valve on waterward side. Concrete stairway on waterward slope. 1-3/4-inch galvanized iron waterline with tap exposed on landward slope 3.4 feet below crown. 4 foot by 5.1 foot concrete distribution box at landward toe. 1-1/4-inch conduit through levee, 2.0 feet below crown. (ABO No. 10080 - Yturalde)						
FS Date: 1/9/2014

WS view: pipe (left), pump house/store, and concrete steps.

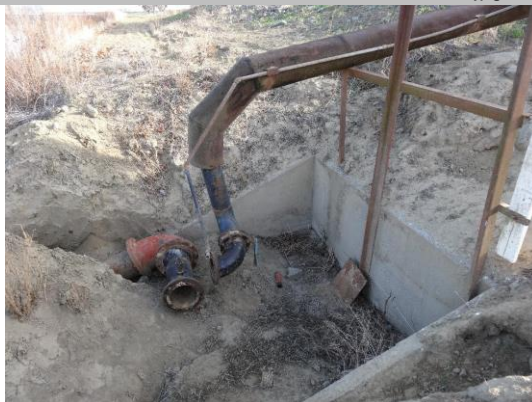
Photo 2 of 2 : UCIP_FA_2016_28903_53161.jpg

WS view: U type headwall and 8-inch pipe sleeved into 14-inch steel pipe. Pump was removed from the pipe.

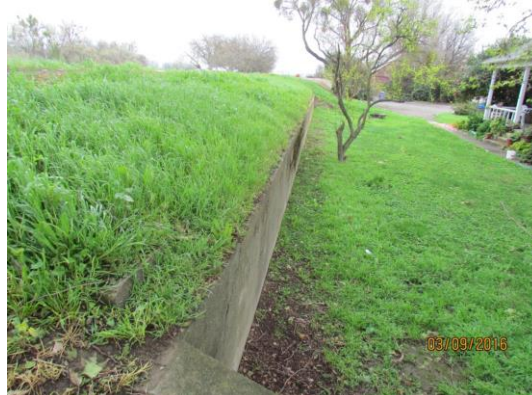
Photo 1 of 1 : FA_2016_RD1500_189_4_20160913_00004.jpg

LM Start	1.33	Rating **	M	Issue No.	4
LM End	1.33	Issue Type +	En	Location *	LS
Category	Earthen Levee			GPS Latitude/Longitude	
				Start	End
Item	Vegetation			38.770023 °	38.770023 °
				-121.690575 °	-121.690575 °
DWR ID	DWR_RD1500_01_s_2012_4				
Comment Code					
V6 : Landscaping					
Inspector Comment					
Retaining wall built into the levee.

View of the retaining wall that is in USACE as-builts on the landward side of the levee looking upstream. Wall cuts into levee toe. Spring 2016.

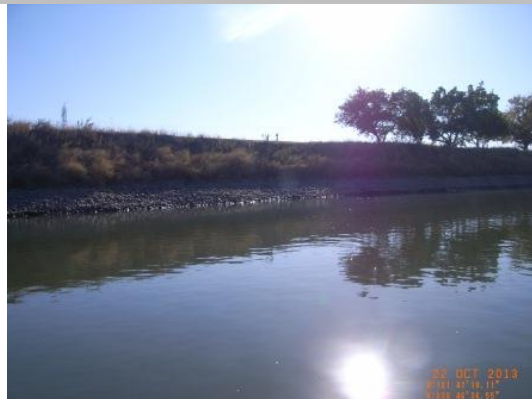
Photo 1 of 1 : FA_2016_RD1500_189_6_20160913_00006.jpg

LM Start	1.34	Rating **	A/W	Issue No.	6
LM End	1.95	Issue Type +	Ma	Location *	WS
Category	Supplemental			GPS Latitude/Longitude	
				Start	End
Item	2015 USACE Erosion Survey, DRAFT			38.770390 °	38.777282 °
				-121.690553 °	-121.685841 °
DWR ID	DWR_RD1500_01_s_2016_6				
Comment Code					
Inspector Comment					
2006 - New erosion upstream, new bank failures near levee but still fairly wide berm in most places. 2008 - Large berm, questionable as to if it should remain in the inventory. 2010 - Minor new erosion, old cobble starting to fail. 2011 - Cobble continues to unravel and additional slumping. 2012 - Minor new erosion at bank mid point. 2013 - Minor new erosion. 2015: No observed changes. [2015 Site ID: SAC 86-3 L]

USACE 2013 Photo #1

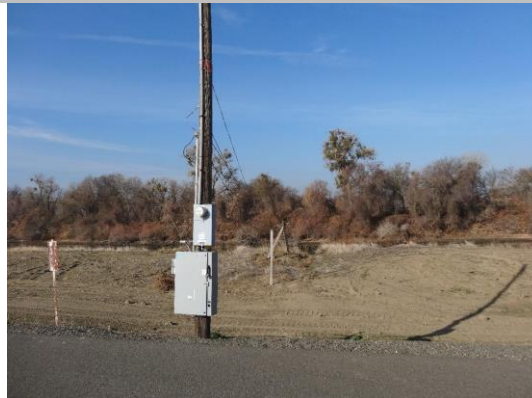
Photo 1 of 2 : UCIP_FA_2016_28204_51875.jpg

LM Start	1.63	Rating **	M	Issue No.	2584
LM End	1.63	Issue Type +	En	Location *	WS
Category	Supplemental			GPS Latitude/Longitude	
				Start	End
Item	DWR UCIP Field Study			38.772862 °	38.772862 °
				-121.686453 °	-121.686453 °
DWR ID					
Comment Code					
Inspector Comment					
FS_ID:28204					
DS_ID:20033					
EP_NO: N/A					
Repair Type: Non-Urgent					
Crossing Status: Found					
UCIP Comments: - pump removed- erosion around pump station.- overhead electrical line.					
FIELD_STRUCT_DESC: 10-inch diameter steel irrigation pipeline through levee, 10.0 feet below crown. Pump and gate valve on bank.					
Service pole and switch panel on waterward shoulder. Pipe crosses irrigation ditch and discharges into steel distribution box on the field.					
FS Date: 1/9/2014

WS view: Service pole with control panel on levee shoulder.

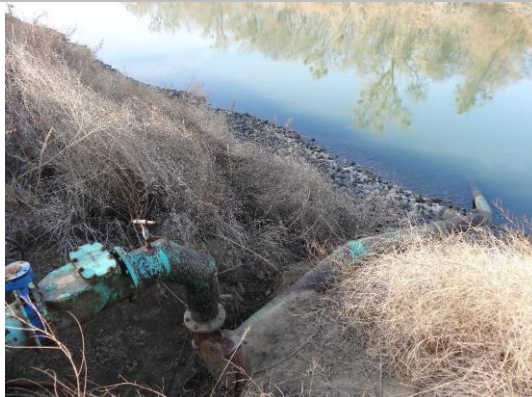
Photo 2 of 2 : UCIP_FA_2016_28204_51874.jpg

LM Start	1.63	Rating **	M	Issue No.	2584 (cont)	
LM End	1.63	Issue Type +	En	Location *	WS	
Category	Supplemental			GPS Latitude/Longitude		
				Start	End	
Item	DWR UCIP Field Study			38.772862 °	38.772862 °	
				-121.686453 °	-121.686453 °	
DWR ID						
Comment Code						
Inspector Comment						
FS_ID:28204						
DS_ID:20033						
EP_NO: N/A						
Repair Type: Non-Urgent						
Crossing Status: Found						
UCIP Comments: - pump removed- erosion around pump station.- overhead electrical line.						
FIELD_STRUCT_DESC: 10-inch diameter steel irrigation pipeline through levee, 10.0 feet below crown. Pump and gate valve on bank.						
Service pole and switch panel on waterward shoulder. Pipe crosses irrigation ditch and discharges into steel distribution box on the field.						
FS Date: 1/9/2014

WS view: pump (removed) and inlet pipe on river bank.

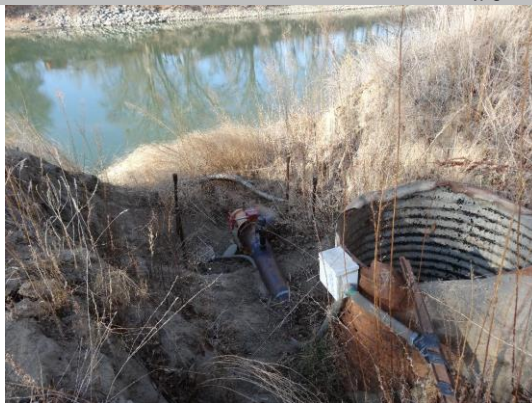
Photo 1 of 2 : UCIP_FA_2016_28263_51965.jpg

Comment Code						
Inspector Comment						
FS_ID:28263						
DS_ID:20034						
EP_NO: 16146						
Repair Type: Non-Urgent						
Crossing Status: Found						
UCIP Comments: - pump removed- overhead powerline- pile structure abandoned- levee slope erosion due to leaky siphon breaker on landside.						
FIELD_STRUCT_DESC: 12-inch diameter steel pipe through levee, 12.0 feet below crown. Pump mounted on river bank, butterfly valve on waterward side. Power pole with one anchor on waterside slope. Pump discharges into 5 foot by 5 foot concrete distribution box (damaged) across the irrigation ditch on the landside. (Cat. I Furlan) (App. No. 16146) O&M Manual Sac 128, March 1960.						
FS Date: 1/9/2014

WS view: Pump (removed and plywood plated), pipe, and gate valve in CMP riser on river bank.

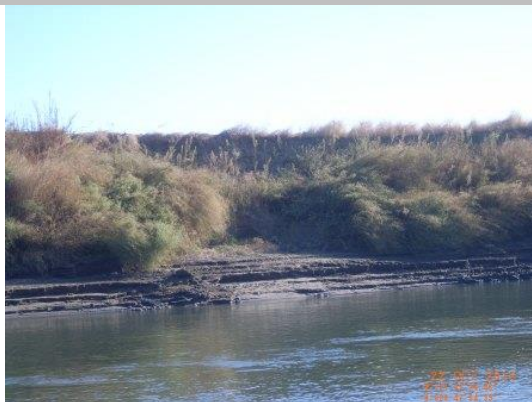
Photo 1 of 1 : FA_2016_RD1500_189_2_20160913_00002.jpg

LM Start	2.30	Rating **	A/W	Issue No.	2
LM End	2.52	Issue Type +	Ma	Location *	WS
Category	Supplemental			GPS Latitude/Longitude	
				Start	End
Item	2015 USACE Erosion Survey, DRAFT			38.781962 °	38.784936 °
				-121.688033 °	-121.690033 °
DWR ID	DWR_RD1500_01_s_2016_2				
Comment Code					
Inspector Comment					
2010 - The upstream end of the repair site at 87.0. Repair did not extend far enough upstream. 2011 - New erosion pockets. 2012 - Minor new erosion at toe. 2013 - Minor new erosion. 2015: Significant new toe erosion. [2015 Site ID: SAC_87-1_L]

USACE 2013 Photo #1

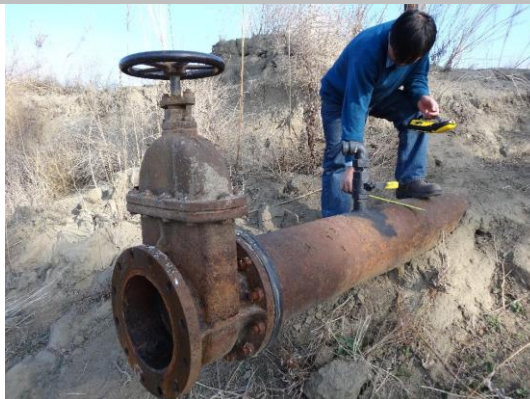
Photo 1 of 2 : UCIP_FA_2016_28264_51971.jpg

FS_ID:28264
DS_ID:20035
EP_NO: 10029
Repair Type: Non-Urgent
Crossing Status: Found
UCIP Comments: - pump removed- outlet plugged- looks abandoned. Found abandoned pipe parts on levee slope and berm.- overhead powerline
FIELD_STRUCT_DESC: Abandoned 12-inch steel irrigation pipe through levee, 11.0-feet below crown. Two metal cutoff walls installed. Pump on bank during irrigation season. Gate valve at waterward toe. Discharges into 2.5x2.5 foot concrete distribution box on landward side of irrigation ditch. (ABO No. 10029 - Anderson). O&M Manual Sac 128, March 1960.
FS Date: 1/9/2014

WS view: steel pipe, gate valve, and pump (removed) on river bank. Looks abandoned.

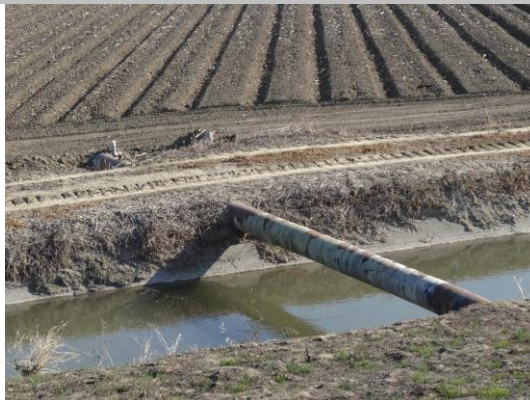
Photo 2 of 2 : UCIP_FA_2016_28264_51970.jpg

LS view: discharge pipe crossing irrigation ditch on landside.

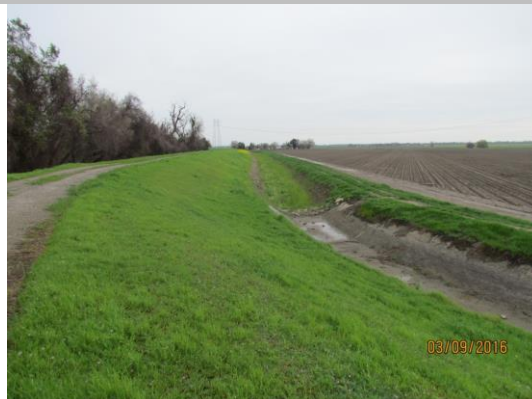
Photo 1 of 1 : FA_2016_RD1500_189_963_20160913_00082.jpg

LM Start	2.54	Rating **	M	Issue No.	963
LM End	3.68	Issue Type +	En	Location *	LS
Category	Earthen Levee			GPS Latitude/Longitude	
				Start	End
Item	Encroachments			38.785351 °	38.797128 °
				-121.689075 °	-121.691047 °
DWR ID	DWR_RD1500_01_s_2012_963				
Comment Code					
DT : Ditch					
Inspector Comment

View of the ditch at the toe of the landward side of the levee looking upstream. Spring 2016.

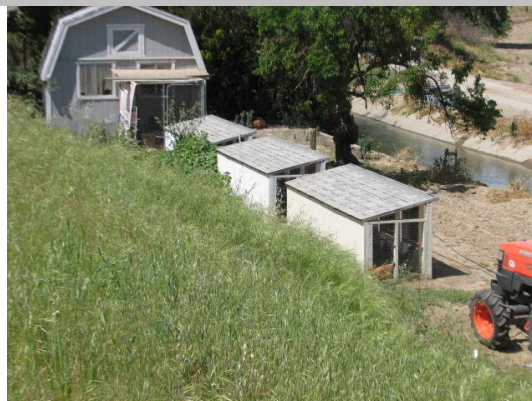
Photo 2 of 2 : FA_2016_RD1500_189_7_20160913_00008.jpg

LM Start	3.93	Rating **	M	Issue No.	7 (cont)	
LM End	3.93	Issue Type +	En	Location *	LS	
Category	Earthen Levee			GPS Latitude/Longitude		
				Start		End
Item	Encroachments			38.797516 °		38.797516 °
				-121.695645 °		-121.695645 °
DWR ID	DWR_RD1500_01_s_2012_7					
Comment Code						
BU : Building						
Inspector Comment

Chicken coupes have been added along the toe of the levee. Spring

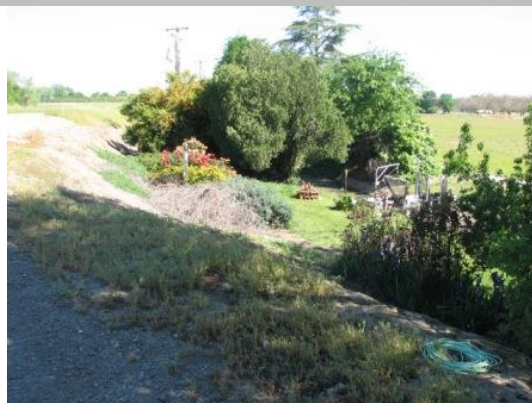
Photo 1 of 2 : FA_2016_RD1500_189_8_20160913_00009.jpg

LM Start	3.97	Rating **	A/W	Issue No.	8
LM End	3.97	Issue Type +	En	Location *	LS
Category	Earthen Levee			GPS Latitude/Longitude	
				Start	End
Item	Vegetation			38.797838 °	38.797838 °
				-121.696046 °	-121.696046 °
DWR ID	DWR_RD1500_01_s_2012_8				
Comment Code					
V6 : Landscaping					
Inspector Comment					
Most of the vegetation has been removed. There appears to be new landscaping at the toe of the levee.

The landscape is planted into the encroachment zone within 15' of the toe.

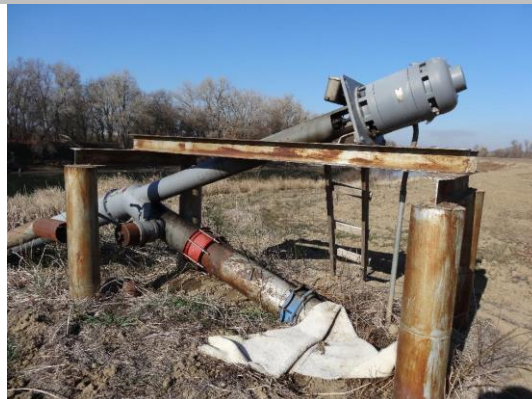
Photo 1 of 2 : UCIP_FA_2016_28272_52012.jpg

LM Start	4.01	Rating **	M	Issue No.	2587
LM End	4.01	Issue Type +	En	Location *	LS
Category	Supplemental			GPS Latitude/Longitude	
				Start	End
Item	DWR UCIP Field Study			38.798436 °	38.798436 °
				-121.696280 °	-121.696280 °
DWR ID					
Comment Code					
Inspector Comment					
FS_ID:28272 DS_ID:20037 EP_NO: 3638 Repair Type: Non-Urgent Crossing Status: Found UCIP Comments: - No protection for pressure breaker. FIELD_STRUCT_DESC: 12-inch steel irrigation pipe through levee, 2.4 feet below crown. Slant pump on berm. Pressure breaker on landward slope. Service pole at landward toe. Discharges into 36-inch diameter concrete standpipe on landside. (App. No. 3638 - J. Waters) FS Date: 1/9/2014

WS view: slant pump on steel frame on levee berm.

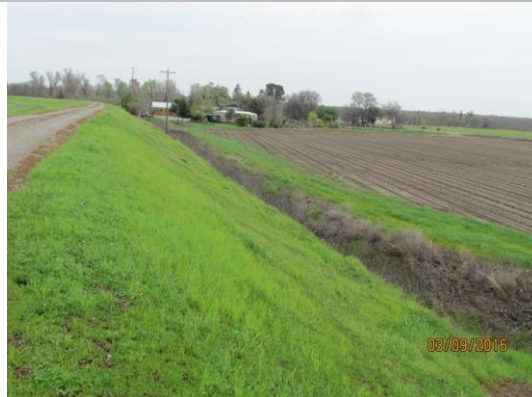
Photo 1 of 1 : FA_2016_RD1500_189_54_20160913_00040.jpg

LM Start	4.02	Rating **	M	Issue No.	54
LM End	4.12	Issue Type +	En	Location *	LS
Category	Earthen Levee			GPS Latitude/Longitude	
				Start	End
Item	Encroachments			38.798526 °	38.800063 °
				-121.696326 °	-121.696622 °
DWR ID	DWR_RD1500_01_s_2012_54				
Comment Code					
DT : Ditch					
Inspector Comment					
Ditch runs along the toe of the levee.

View of the ditch on the landward side of the levee looking upstream.
Spring 2016.

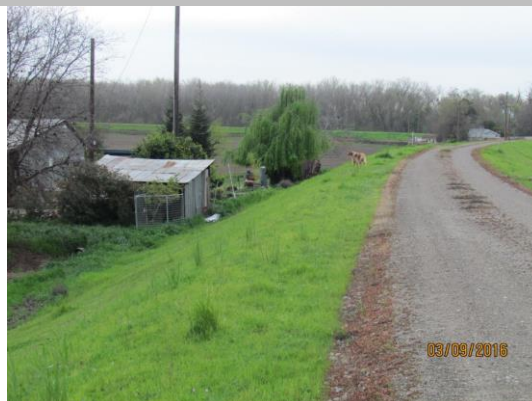
Photo 1 of 1 : FA_2016_RD1500_189_11_20160913_00012.jpg

LM Start	4.16	Rating **	M	Issue No.	11
LM End	4.16	Issue Type +	En	Location *	LS
Category	Earthen Levee			GPS Latitude/Longitude	
				Start	End
Item	Encroachments			38.800548 °	38.800548 °
				-121.696751 °	-121.696751 °
DWR ID	DWR_RD1500_01_s_2012_11				
Comment Code					
BU : Building					
Inspector Comment

View of the equipment shed on the landward side of the levee looking downstream. Spring 2016.

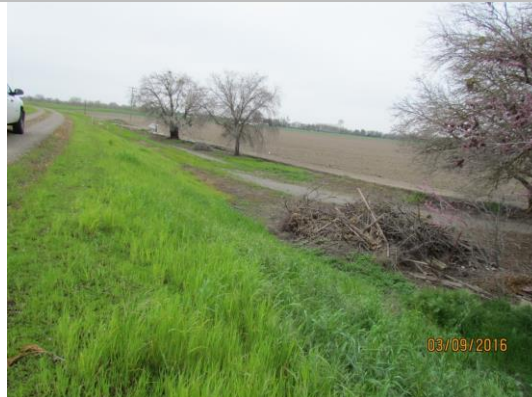
Photo 1 of 1 : FA_2016_RD1500_189_142_20160913_00070.jpg

LM Start	4.61	Rating **	M	Issue No.	142
LM End	4.61	Issue Type +	En	Location *	LS
Category	Earthen Levee			GPS Latitude/Longitude	
				Start	End
Item	Encroachments			38.803509 °	38.803509 °
				-121.703046 °	-121.703046 °
DWR ID	DWR_RD1500_01_s_2016_142				
Comment Code					
PR : Prunings					
Inspector Comment

View of the pruning pile on the landward side of the levee looking upstream. Spring 2016.

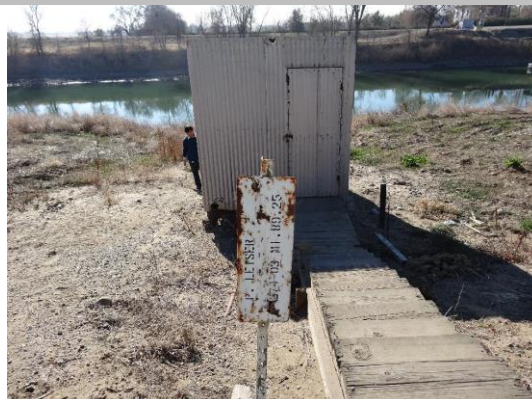
Photo 1 of 2 : UCIP_FA_2016_28913_53184.jpg

LM Start	5.19	Rating **	M	Issue No.	2567
LM End	5.19	Issue Type +	En	Location *	WS
Category	Supplemental			GPS Latitude/Longitude	
				Start	End
Item	DWR UCIP Field Study			38.802322°	38.802322°
				-121.712908°	-121.712908°
DWR ID					
Comment Code					
Inspector Comment					
FS_ID:28913 DS_ID:20041 EP_NO: 10056 Repair Type: Non-Urgent Crossing Status: Found UCIP Comments: Depression on landside levee slope around siphon breaker due to leakage.Siphon breaker needs protection. FIELD_STRUCT_DESC: 18-inch steel irrigation pipe through levee, 4.0 feet below crown. 1 1/2-inch conduit through levee, 20 ft below crown. Slant pump in CM pump house on waterside. Wooden steps on waterside slope. Siphon breaker on landside slope. A 5 ft x 5 ft Concrete distribution box at landward toe. (ABO No. 10056 - Leiser) O&M Manual Sac 128, March 1960. FS Date: 1/9/2014

WS view: wooden steps to pump house on levee berm.

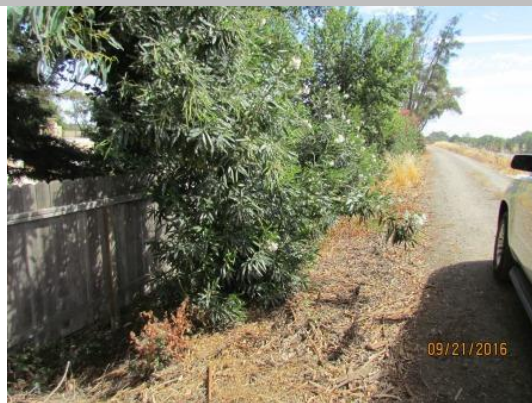
Photo 1 of 1 : FA_2016_RD1500_189_125_20160926_00269.jpg

LM Start	5.32	Rating **	M	Issue No.	125
LM End	5.35	Issue Type +	En	Location *	LS
Category	Earthen Levee			GPS Latitude/Longitude	
				Start	End
Item	Vegetation			38.803181 °	38.803344 °
				-121.715141 °	-121.715616 °
DWR ID	DWR_RD1500_01_f_2016_125				
Comment Code					
V6 : Landscaping					
Inspector Comment

View of vegetation on LS slope. Fall 2016.

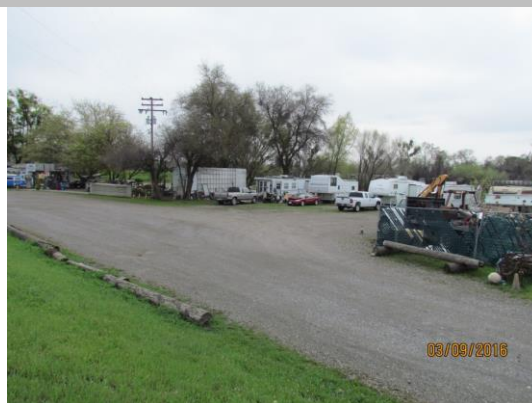
Photo 1 of 2 : FA_2016_RD1500_189_52_20160913_00038.jpg

LM Start	5.61	Rating **	M	Issue No.	52
LM End	5.69	Issue Type +	En	Location *	WS
Category	Earthen Levee			GPS Latitude/Longitude	
				Start	End
Item	Encroachments			38.803067 °	38.803238 °
				-121.720270 °	-121.721847 °
DWR ID	DWR_RD1500_01_s_2012_52				
Comment Code					
BU : Building					
Inspector Comment					
Sting Rayz Beach Boardwalk Marina on the waterside berm.

View of Sting Rayzs RV Park on the berm of the waterward side of the levee looking downstream. Spring 2016.

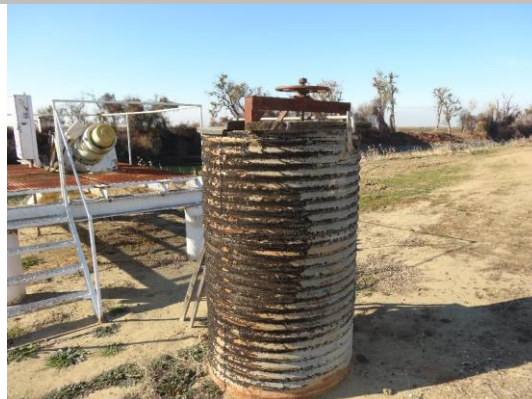
Photo 1 of 2 : UCIP_FA_2016_28286_52059.jpg

Comment Code					
Inspector Comment					
FS_ID:28286 DS_ID:20044 EP_NO: 10074 Repair Type: Non-Urgent Crossing Status: Found UCIP Comments: Not found- 36-inch concrete standpipe on landside. 2-inch conduit through the levee.Pipe description does not match with field observaion. It needs review and more info from LMA.A capped pipe, air vent, and butterfly valve found on landside toe. But, it is not clear whether these belongs to this crossing. FIELD_STRUCT_DESC: 18-inch steel irrigation pipe and electric conduit through levee, 13.0 feet below crown. Slide gate in 42-inch Corrugated metal riser on berm. Slant pump on steel pump platform on berm. Installed by USCE, 1959. (ABO No. 10074 - TI&T Co.) O&M Manual Sac 128, March 1960. FS Date: 1/9/2014

WS view: CMP riser with slide gate and slant pump on steel platform on levee berm.

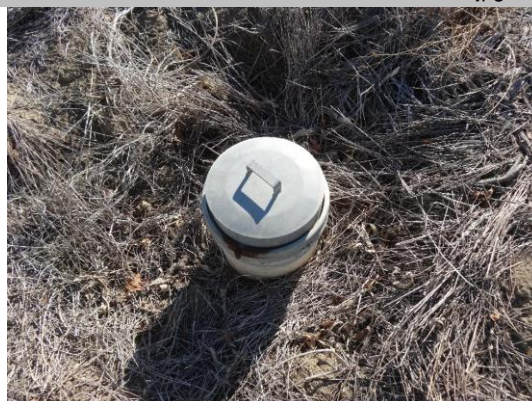
Photo 2 of 2 : UCIP_FA_2016_28286_52058.jpg

LS view: a capped pipe on levee toe. It is not clear whether this pipe is connected to the CMP riser on waterside.

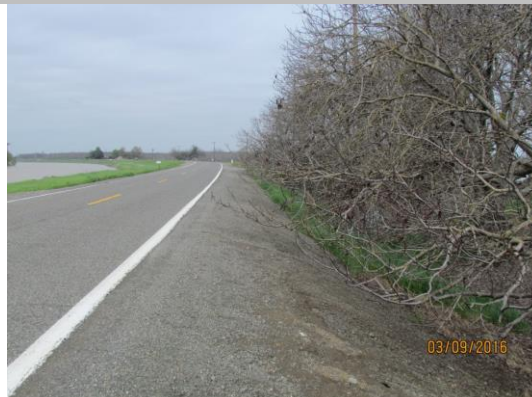
Photo 1 of 1 : FA_2016_RD1500_189_217_20160913_00081.jpg

LM Start	7.15	Rating **	M	Issue No.	217
LM End	7.15	Issue Type +	Ma	Location *	LS
Category	Earthen Levee			GPS Latitude/Longitude	
				Start	End
Item	Trim / Thin Trees			38.824119 °	38.824119 °
				-121.722776 °	-121.722776 °
DWR ID	DWR_RD1500_01_s_2012_217				
Comment Code					
T1 : Trim trees to at least five feet above ground level.					
Inspector Comment

View of the trees on the landward side of the levee looking upstream.
Spring 2016.

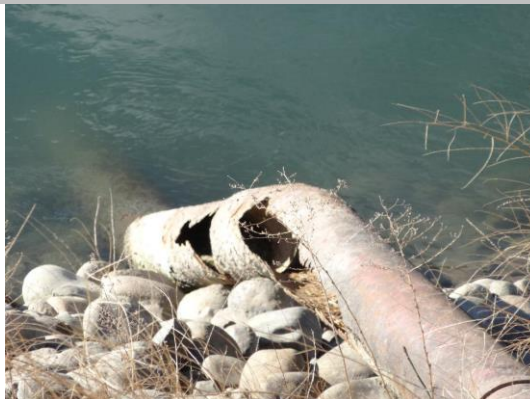
Photo 2 of 2 : UCIP_FA_2016_28923_53201.jpg

Item	DWR UCIP Field Study			38.824208 °	38.824208 °	
				-121.722793 °	-121.722793 °	
DWR ID						
Comment Code						
Inspector Comment						
FS_ID:28923 DS_ID:20047 EP_NO: 10048 Repair Type: Non-Urgent Crossing Status: Found UCIP Comments: An abandoned pipe. Highly deteriorated pipe on river bank.Needs proper abandonment.Not found- Siphon breaker at landward levee toe. FIELD_STRUCT_DESC: *ABANDONED* 10-inch diameter irrigation pipe through levee, 4.5 feet below crown. A 1-inch conduit through levee, 4.5 feet below crown. A pump in metal shed on bank. Gate valve on waterside end. Service pole and 24-inch Concrete standpipe at landside toe. Installed by USCE, 1958 (ABO. No. 10048-King) O&M Manual Sac 128, March 1960. FS Date: 1/9/2014

WS view: deteriorated and abandoned steel pipe on river bank.

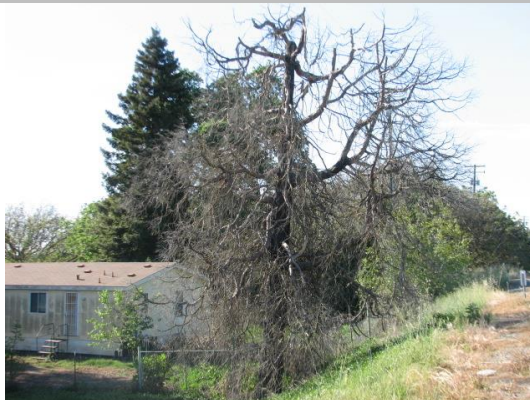
Photo 1 of 1 : FA_2016_RD1500_189_1343_20160913_00088.jpg

LM Start	7.20	Rating **	A/W	Issue No.	1343
LM End	7.20	Issue Type +	Ma	Location *	LS
Category	Earthen Levee			GPS Latitude/Longitude	
				Start	End
Item	Vegetation			38.824900 °	38.824900 °
				-121.722851 °	-121.722851 °
DWR ID	DWR_RD1500_01_s_2014_1343				
Comment Code					
V7 : Trees / Woody Vegetation					
Inspector Comment

Monitor tree that may pose a future threat to the integrity of the levee.
Spring 2014

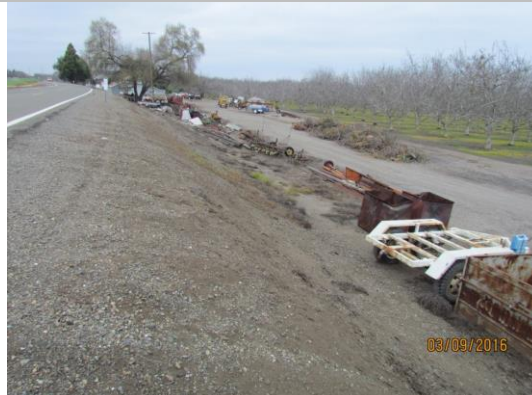
Photo 1 of 1 : FA_2016_RD1500_189_16_20160913_00015.jpg

LM Start	7.49	Rating **	M	Issue No.	16
LM End	7.49	Issue Type +	En	Location *	LS
Category	Earthen Levee			GPS Latitude/Longitude	
				Start	End
Item	Encroachments			38.828944 °	38.828944 °
				-121.724329 °	-121.724329 °
DWR ID	DWR_RD1500_01_s_2012_16				
Comment Code					
EQ : Equipment					
Inspector Comment

View of the equipment along the levee toe on the landward side of the levee looking upstream. Spring 2016.

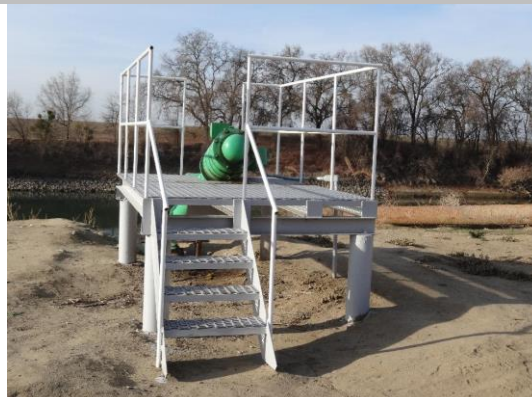
Photo 1 of 2 : UCIP_FA_2016_50199_53204.jpg

Comment Code					
Inspector Comment					
FS_ID:50199 DS_ID:20049 EP_NO: 8147 Repair Type: Non-Urgent Crossing Status: Found UCIP Comments: 08/29/2016: New pumps installed at LS toe ditch, could not find permit for this work. No signs of leakage or excessive vegetation growth in alignment with the pipe. Riser silted in; recommend installing a lid. Crossing has been downgraded from Urgent to Non-Urgent. (K. Fazel - UCIP)01/10/2014:Not found- slide gate in 48-inch corrugated metal riser at waterside toe.Repair works under way. Contact LMA for repair works information.Sign of leaky pipe and siphon breaker. This needs detailed investigation. (P. Amatya - DWR) FIELD_STRUCT_DESC: 12-inch steel irrigation pipe through the levee, 4.8 feet below the crown. Slant pump mounted on steel structure at the edge of the berm. A 4 by 4-foot concrete distribution box at the landside (LS) toe with newly installed pumps with shut-off valves. (Permit No. 8147, 1972 - Driver). [Additional Reference(s): DWR Levee Log, 2005. USACE Sacramento O&M Manual 128 (HLM 7.79)]. FS Date: 8/29/2016

WS view: slant pump on steel platform on end of berm.

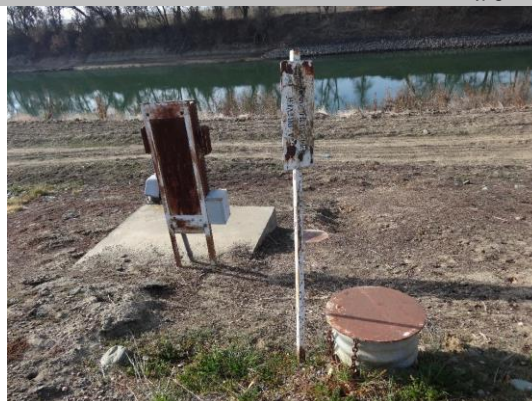
Photo 1 of 2 : UCIP_FA_2016_28323_52125.jpg

Comment Code					
Inspector Comment					
FS_ID:28323 DS_ID:20051 EP_NO: 13882 Repair Type: Non-Urgent Crossing Status: Found UCIP Comments: Power pole on landside. 2-inch conduit through the levee. Service box on waterside. Concrete pad on waterside. Not found- Concrete distribution box on landward side; not found- gate valve on waterside. Need proper abandonment. Pipe visible on river bank, waterside levee slope and landside field. FIELD_STRUCT_DESC: Abandoned 6-inch diameter steel irrigation pipe and electric conduit through levee, 4.9 feet below crown. 1-1/2 conduit through levee, 4.0 feet below crown. Service pole at landward levee toe. (ABO. No. 10062-Moroni, App. No. 13882) FS Date: 1/10/2014

WS view: CMP with air vent (right), concrete pad (left), and switch panel (left) on levee slope.

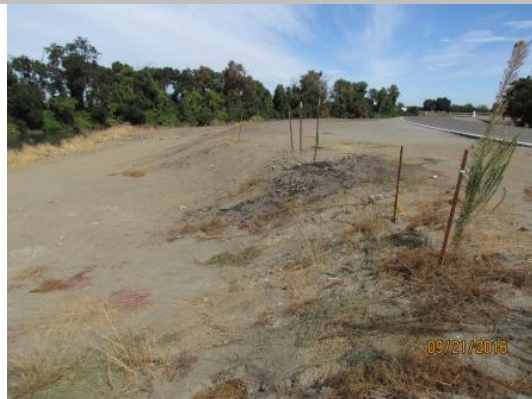
Photo 1 of 2 : FA_2016_RD1500_189_150_20160926_00266.jpg

LM Start	8.29	Rating **	M	Issue No.	150
LM End	8.29	Issue Type +	Ma	Location *	WS
Category	Earthen Levee			GPS Latitude/Longitude	
				Start	End
Item	Erosion / Bank Caving			38.838802 °	38.838802 °
				-121.729598 °	-121.729598 °
DWR ID	DWR_RD1500_01_s_2016_150				
Comment Code					
E2 : Schedule repair of erosion site prior to the next inspection.					
Inspector Comment					
Erosion caused by vehicles and runoffs from rain.

Updated view of the erosion site on waterward side of the levee. Fall 2016.

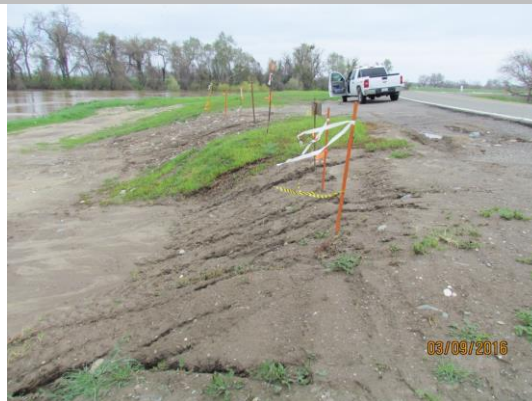
Photo 2 of 2 : FA_2016_RD1500_189_150_20160913_00071.jpg

View of the erosion on the waterward side of the levee looking upstream. Spring 2016.

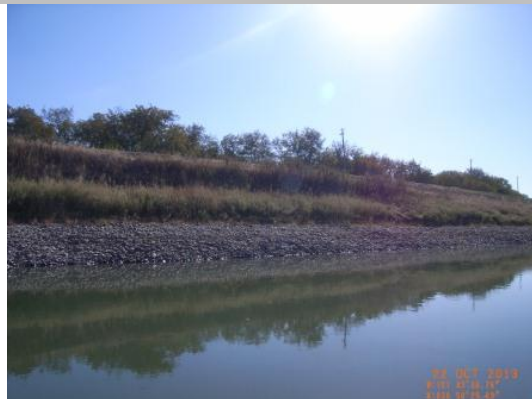
Photo 1 of 1 : FA_2016_RD1500_189_3_20160913_00003.jpg

LM Start	8.33	Rating **	M	Issue No.	3
LM End	8.47	Issue Type +	Ma	Location *	WS
Category	Supplemental			GPS Latitude/Longitude	
				Start	End
Item	2015 USACE Erosion Survey, DRAFT			38.839546 °	38.840347 °
				-121.729591 °	-121.726857 °
DWR ID	DWR_RD1500_01_s_2016_3				
Comment Code					
Inspector Comment					
1997 - Damage to cobble revetment on top left bank and toe damage. 2004 - Site is pretty minor. 2010 - Cobbles continue to deteriorate. 2011 - Minor new erosion at the toe. 2013 - Might be able to shorten due to deposition. 2015: Site shortened, downstream end has plenty of berm and deposited material, well vegetated. [2015 Site ID: SAC_92-8_L]

USACE 2013 Photo #1

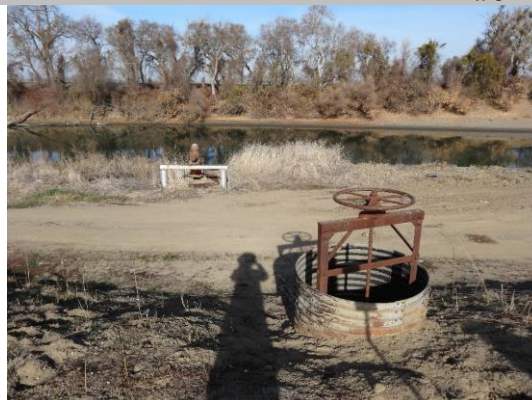
Photo 1 of 2 : UCIP_FA_2016_28324_52131.jpg

LM Start	8.35	Rating **	M	Issue No.	2555
LM End	8.35	Issue Type +	En	Location *	WS
Category	Supplemental			GPS Latitude/Longitude	
				Start	End
Item	DWR UCIP Field Study			38.839446 °	38.839446 °
				-121.728901 °	-121.728901 °
DWR ID					
Comment Code					
Inspector Comment					
FS_ID:28324 DS_ID:20053 EP_NO: 10064 Repair Type: Non-Urgent Crossing Status: Found UCIP Comments: Looks abandoned as service pole not found.May need proper abandonment. FIELD_STRUCT_DESC: 2 foot by 2 foot concrete box culvert through levee, 13.0 feet below crown. Pump on 6 foot diameter concrete pump well on berm. Slide gate in 42-inch CM riser on waterward slope. 4.5 foot by 6 foot concrete distribution box at landward toe. (ABO No. 10064 - Nix) FS Date: 1/10/2014

WS view: slide gate in CMP riser on levee slope. Looks abandoned.

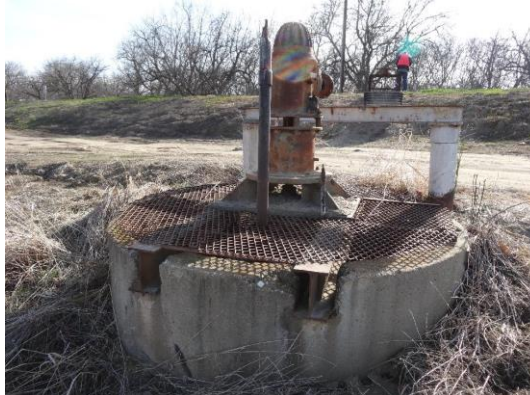
Photo 2 of 2 : UCIP_FA_2016_28324_52130.jpg

LM Start	8.35	Rating **	M	Issue No.	2555 (cont)	
LM End	8.35	Issue Type +	En	Location *	WS	
Category	Supplemental			GPS Latitude/Longitude		
				Start	End	
Item	DWR UCIP Field Study			38.839446 °	38.839446 °	
				-121.728901 °	-121.728901 °	
DWR ID						
Comment Code						
Inspector Comment						
FS_ID:28324 DS_ID:20053 EP_NO: 10064 Repair Type: Non-Urgent Crossing Status: Found UCIP Comments: Looks abandoned as service pole not found.May need proper abandonment. FIELD_STRUCT_DESC: 2 foot by 2 foot concrete box culvert through levee, 13.0 feet below crown. Pump on 6 foot diameter concrete pump well on berm. Slide gate in 42-inch CM riser on waterward slope. 4.5 foot by 6 foot concrete distribution box at landward toe. (ABO No. 10064 - Nix) FS Date: 1/10/2014

WS view: vertical pump on concrete sump on levee berm. Looks abandoned.

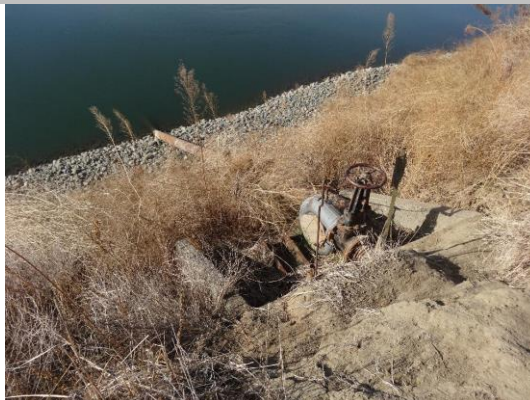
Photo 1 of 2 : UCIP_FA_2016_28343_52145.jpg

LM Start	8.67	Rating **	M	Issue No.	2556	
LM End	8.67	Issue Type +	En	Location *	WS	
Category	Supplemental			GPS Latitude/Longitude		
				Start		End
Item	DWR UCIP Field Study			38.842218 °		38.842218 °
				-121.725728 °		-121.725728 °
DWR ID						
Comment Code						
Inspector Comment						
FS_ID:28343						
DS_ID:20054						
EP_NO: 5518						
Repair Type: Non-Urgent						
Crossing Status: Found						
UCIP Comments: Not found- siphon breaker on landward shoulder.						
Pump removed.						
FIELD_STRUCT_DESC: 10-inch diameter steel irrigation pipe through levee, 2.5 feet below crown. Pump on concrete platform. 1-inch conduit installed in joint trench. Service pole at landward levee toe. Discharges into 4x4 foot concrete distribution box on landward side. Installed in 1966 under application No. 5518 by I.E. Bundock-M.Bundock, River Mile 92.9.						
FS Date: 1/10/2014

WS view: U type concrete headwall, pipe, and pump on river bank.

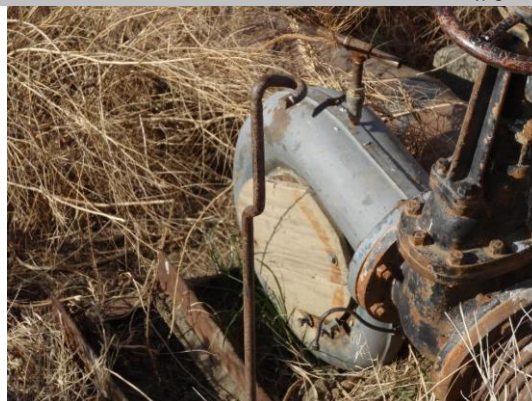
Photo 2 of 2 : UCIP_FA_2016_28343_52144.jpg

LM Start	8.67	Rating **	M	Issue No.	2556 (cont)	
LM End	8.67	Issue Type +	En	Location *	WS	
Category	Supplemental			GPS Latitude/Longitude		
				Start		End
Item	DWR UCIP Field Study			38.842218 °		38.842218 °
				-121.725728 °		-121.725728 °
DWR ID						
Comment Code						
Inspector Comment						
FS_ID:28343 DS_ID:20054 EP_NO: 5518 Repair Type: Non-Urgent Crossing Status: Found UCIP Comments: Not found- siphon breaker on landward shoulder. Pump removed. FIELD_STRUCT_DESC: 10-inch diameter steel irrigation pipe through levee, 2.5 feet below crown. Pump on concrete platform. 1-inch conduit installed in joint trench. Service pole at landward levee toe. Discharges into 4x4 foot concrete distribution box on landward side. Installed in 1966 under application No. 5518 by I.E. Bundock-M.Bundock, River Mile 92.9. FS Date: 1/10/2014

WS view: pipe, pump (removed and capped with plywood), and gate valve on river bank.

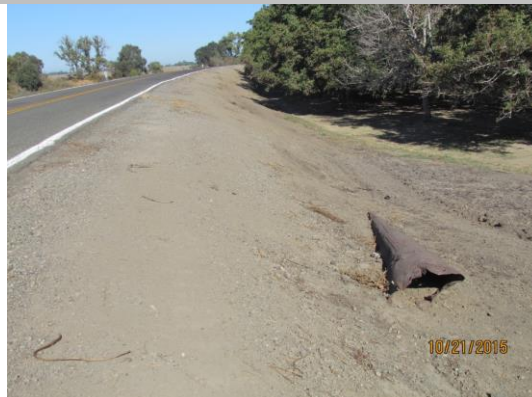
Photo 1 of 1 : FA_2016_RD1500_189_109_20160913_00056.jpg

LM Start	8.79	Rating **	M	Issue No.	109
LM End	8.79	Issue Type +	En	Location *	LS
Category	Earthen Levee			GPS Latitude/Longitude	
				Start	End
Item	Encroachments			38.843481 °	38.843481 °
				-121.727256 °	-121.727256 °
DWR ID	DWR_RD1500_01_f_2015_109				
Comment Code					
DE : Debris					
Inspector Comment					
Abandoned pipe is embedded into levee slope.

View of the abandoned pipe on the landward side of the levee looking upstream. Fall 2015.

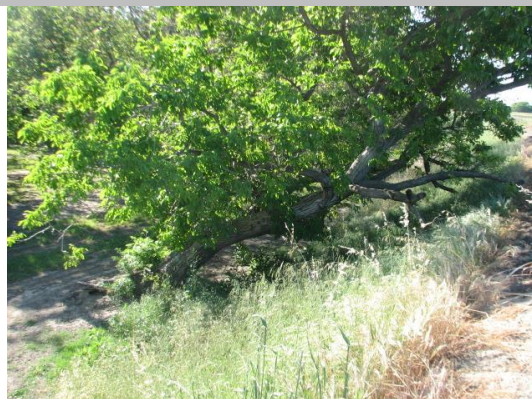
Photo 1 of 3 : FA_2016_RD1500_189_1344_20160913_00089.jpg

LM Start	8.92	Rating **	A/W	Issue No.	1344
LM End	8.92	Issue Type +	Ma	Location *	LS
Category	Earthen Levee			GPS Latitude/Longitude	
				Start	End
Item	Vegetation			38.845076 °	38.845076 °
				-121.728301 °	-121.728301 °
DWR ID	DWR_RD1500_01_s_2014_1344				
Comment Code					
V7 : Trees / Woody Vegetation					
Inspector Comment

The walnut tree at the toe has fallen. The roots are exposed and the branches are holding it up. Spring 2014

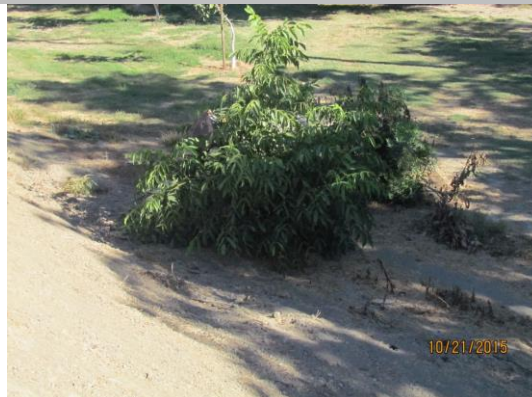
Photo 2 of 3 : FA_2016_RD1500_189_1344_20160913_00090.jpg

The walnut tree has been trimmed but still remains at the landward toe of the levee. Fall 2015.

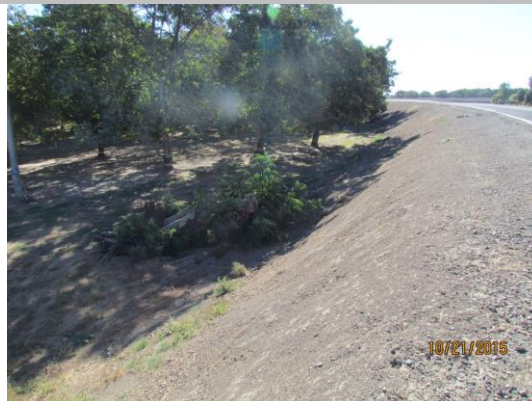
Photo 3 of 3 : FA_2016_RD1500_189_1344_20160913_00091.jpg

Perspective view of the walnut tree on the landward side of the levee looking downstream. Fall 2015.

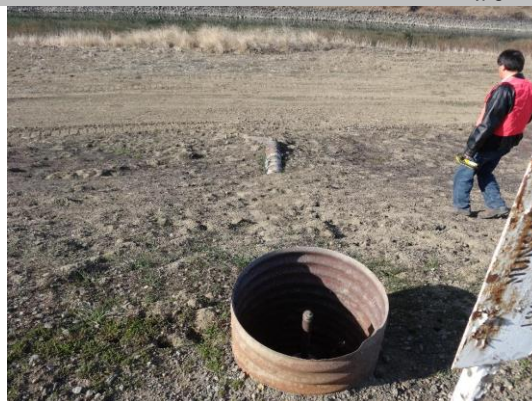
Photo 1 of 2 : UCIP_FA_2016_28363_52167.jpg

FS_ID:28363
DS_ID:20055
EP_NO: 8503
Repair Type: Non-Urgent
Crossing Status: Found
UCIP Comments: Looks abandoned. No pump found on WS. New well near landside. May need proper abandonment. Exposed pipe on waterside. Found steel plate closed pipe on landside.
FIELD_STRUCT_DESC: Abandoned 12-inch steel irrigation pipe through levee, 3.8 feet below crown. Pump on concrete pad with headwall. Siphon breaker in 24-inch CM riser on waterward slope. 1-1/4-inch conduit through levee, 3.0 feet below crown. Service pole with switch panel at landward toe. Concrete distribution box on landward toe. (App. No. 8503 - Munson) O&M Manual Sac 128, March 1960.
FS Date: 1/10/2014

WS view: siphon breaker in CMP riser on levee slope.

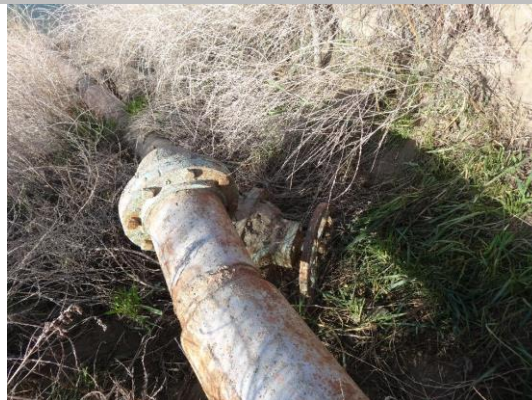
Photo 2 of 2 : UCIP_FA_2016_28363_52166.jpg

WS view: inlet steel pipe with gate valve on river bank.

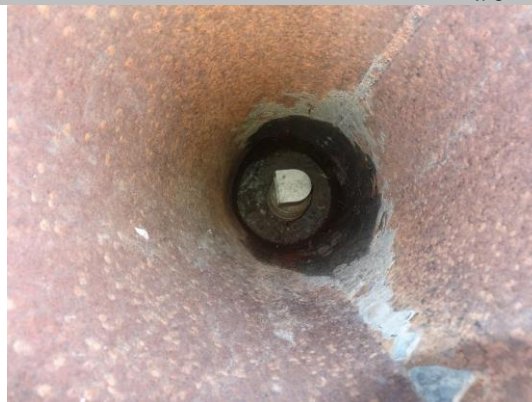
Photo 2 of 2 : UCIP_FA_2016_28364_52175.jpg

LS view: air vent in steel pipe riser on levee slope.

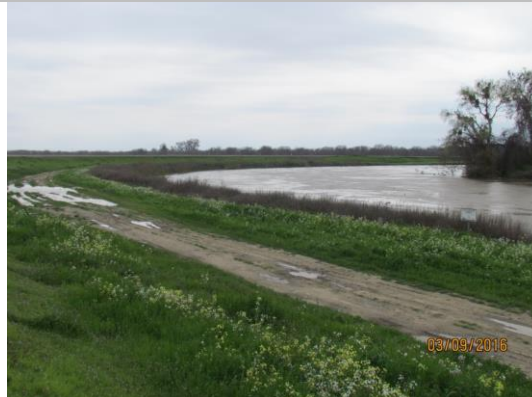
Photo 1 of 2 : FA_2016_RD1500_189_74_20160913_00046.jpg

LM Start	9.40	Rating **	A/W	Issue No.	74
LM End	9.57	Issue Type +	Ma	Location *	WS
Category	Earthen Levee			GPS Latitude/Longitude	
				Start	End
Item	Vegetation			38.850267 °	38.852564 °
				-121.723275 °	-121.723179 °
DWR ID	DWR_RD1500_01_s_2012_74				
Comment Code					
V8 : Environmental Requirements.					
Inspector Comment

View of the revegetation site along the edge of the berm on the waterward side of the levee looking downstream. Spring 2016.

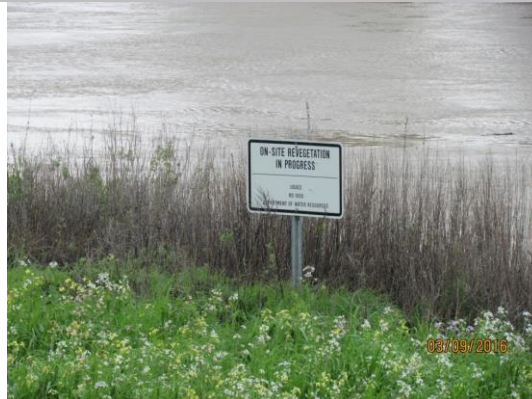
Photo 2 of 2 : FA_2016_RD1500_189_74_20160913_00047.jpg

Sign for the revegetation site by USACE.

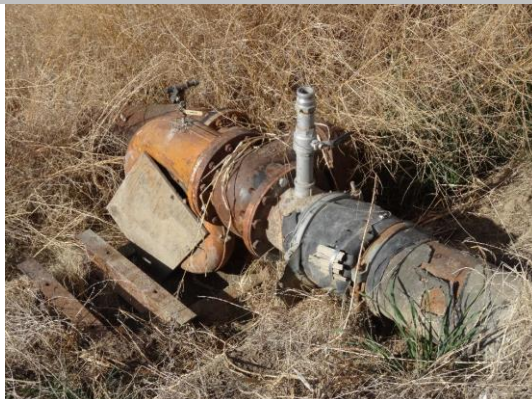
Photo 1 of 2 : UCIP_FA_2016_50069_52188.jpg

FS_ID:50069
DS_ID:20058
EP_NO: 10068
Repair Type: Non-Urgent
Crossing Status: Found
UCIP Comments: 01/10/2014 Surface erosion along pipe alignment on landside. 30-inch concrete pipe in CMP riser on waterside. 30-inch x 24-inch concrete culvert on landside.
FIELD_STRUCT_DESC: 2-foot by 2.5-foot concrete box irrigation culvert diagonally through the levee, 13 feet below the crown. A pump on the river bank, power pole and switch panel on the waterside (WS) berm. Concrete surge box with slide gate on the WS berm. Concrete distribution box at the landside (LS) toe. (Automatic Board Order (ABO) issued as Permit 10068, 1960 - Reel). [Additional Reference(s): DWR Levee Log, 2005. USACE Sacramento O&M Manual 128, March 1960 (HLM 10.22)].
FS Date: 1/10/2014

WS view: pipe and pump with appurtenances on river bank. Pump removed and plugged with plywood.

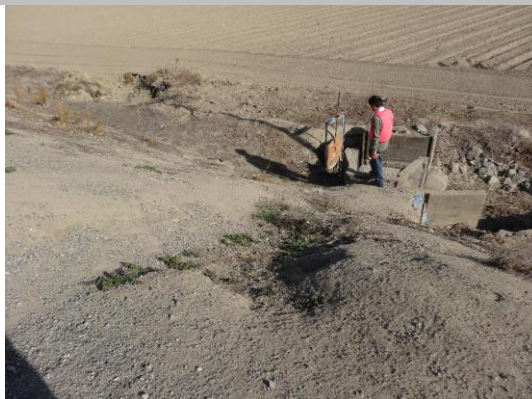
Photo 2 of 2 : UCIP_FA_2016_50069_52189.jpg

LS view: surface erosion along pipe alignment on landside.

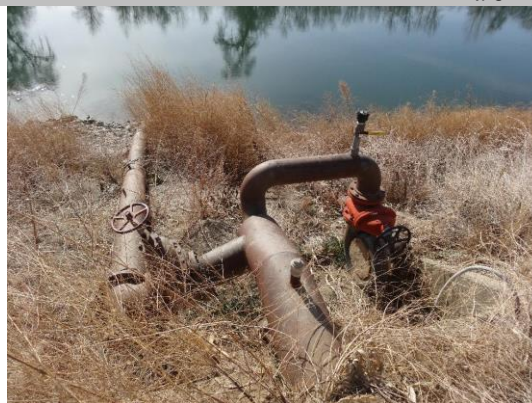
Photo 1 of 2 : UCIP_FA_2016_28925_53210.jpg

LM Start	10.70	Rating **	M	Issue No.	2569
LM End	10.70	Issue Type +	En	Location *	WS
Category	Supplemental			GPS Latitude/Longitude	
				Start	End
Item	DWR UCIP Field Study			38.861550 °	38.861550 °
				-121.737006 °	-121.737006 °
DWR ID					
Comment Code					
Inspector Comment					
FS_ID:28925 DS_ID:20059 EP_NO: N/A Repair Type: Non-Urgent Crossing Status: Found UCIP Comments: Pump removed.Obstructed siphon breaker in CMP riser on landside. FIELD_STRUCT_DESC: A 12-inch diameter steel irrigation pipe through levee, 4.3 feet below crown. A 1-1/2 conduit through levee. 2.0 feet below crown. Pump on river bank, siphon breaker on landside shoulder. A 8x6 ft. concrete distribution box and service pole at landside toe. O&M Manual Sac 128, March 1960. FS Date: 1/10/2014

WS view: pipe, pump (removed and plugged with plywood), headwall, and appurtenances on river bank.

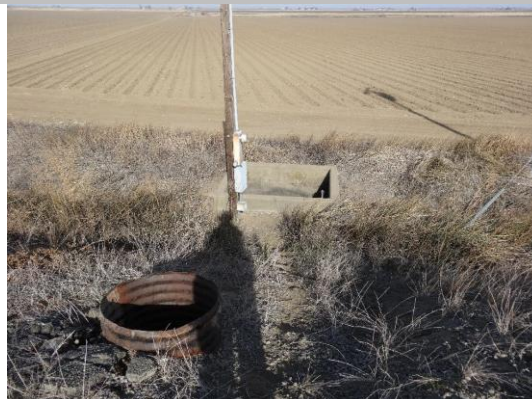
Photo 2 of 2 : UCIP_FA_2016_28925_53209.jpg

LS view: siphon breaker in CMP riser (bottom) on levee slope and concrete distribution box (top) on levee toe.

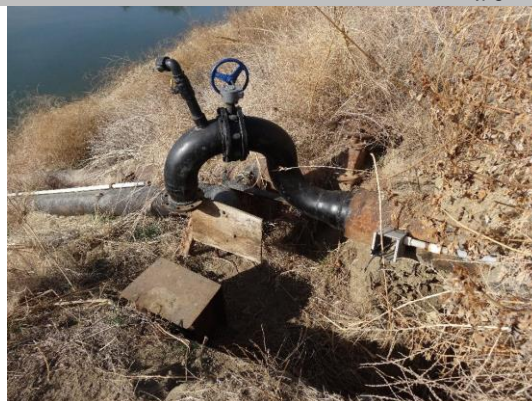
Photo 1 of 2 : UCIP_FA_2016_50043_52213.jpg

FS_ID:50043
DS_ID:20060
EP_NO: 10068
Repair Type: Urgent
Crossing Status: Found
UCIP Comments: 08/29/2016 Pot hole in alignment with pipe is still present on levee crown. Sloughing of LS slope is in alignment with pipe. Permit underway for installation of new pipe so urgent category will soon be corrected. Siemens service pole may be unauthorized. Otherwise same as last inspection.01/10/2014 Pump removed.10-inch pipe joined to 14-inch pipe.Wet, some vegetations, and subsidence along pipe alignment on landside. This needs detailed investigation.
FIELD_STRUCT_DESC: 14-inch steel irrigation pipe through the levee, 4.7 feet below the crown. Pump and gate valve on concrete platform on the waterside (WS) bank. Switch control house and new Siemens service pole with meter on the waterside (WS) shoulder. Siphon breaker on the landside (LS) slope. Concrete distribution box on the LS. (Automatic Board Order (ABO) issued as Permit No. 10068, 1974 - Reel). [Additional Reference(s): DWR Levee Log, 2005. USACE Sacramento O&M Manual 128, March 1960 (HLM 11.35)].

WS view: pipe, pump (removed and plugged with plywood plate), and appurtenances on river bank.

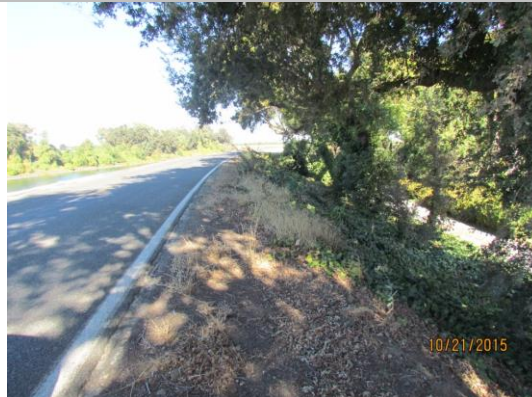
Photo 1 of 1 : FA_2016_RD1500_189_20_20160913_00017.jpg

LM Start	11.30	Rating **	M	Issue No.	20
LM End	11.30	Issue Type +	En	Location *	LS
Category	Earthen Levee			GPS Latitude/Longitude	
				Start	End
Item	Vegetation			38.866383 °	38.866383 °
				-121.745911 °	-121.745911 °
DWR ID	DWR_RD1500_01_s_2012_20				
Comment Code					
V6 : Landscaping					
Inspector Comment

View of the landscaping on the landward side of the levee looking upstream. Fall 2015.

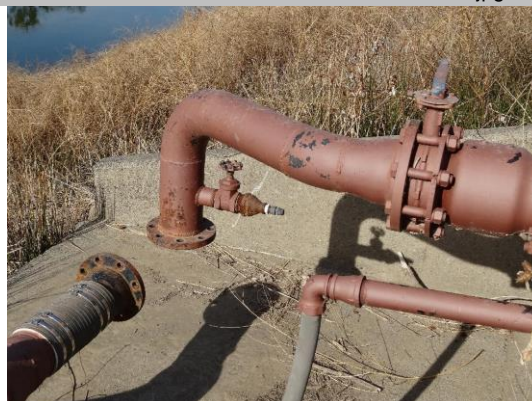
Photo 1 of 2 : UCIP_FA_2016_50198_52220.jpg

Comment Code					
Inspector Comment					
FS_ID:50198 DS_ID:20061 EP_NO: 10041 Repair Type: Non-Urgent Crossing Status: Found UCIP Comments: 08/29/2016 Depressions cited previously are a make-shift staircase and not an indication of a problem with pipe. Pipe partiallay exposed on LS slope which should be backfilled. Crossing has been downgraded from Urgent to Non-Urgent. (K. Fazel - UCIP)01/10/2014 Depressions on both sides of the levee slope. It needs more investigation.Pump removed. (P. Amatya - DWR) FIELD_STRUCT_DESC: 8-inch steel irrigation pipe through the levee, 4 feet below the crown. Pump and gate valve on concrete pump platform on bank. Corrugated metal switch house on waterside (WS). Service pole on WS shoulder. 8-foot by 6-foot (inside dimensions) concrete distribution box on the landside (LS). Pole at the LS toe. (Automatic Board Order (ABO) issued as Permit No. 10041, 1974 - Duffy) [Additional Reference(s): DWR Levee Log, 2005. USACE Sacramento O&M Manual 128, March 1960 (HLM 11.57)]. FS Date: 8/29/2016

WS view: pipe, pump (removed), headwall, and appurtenances on river bank.

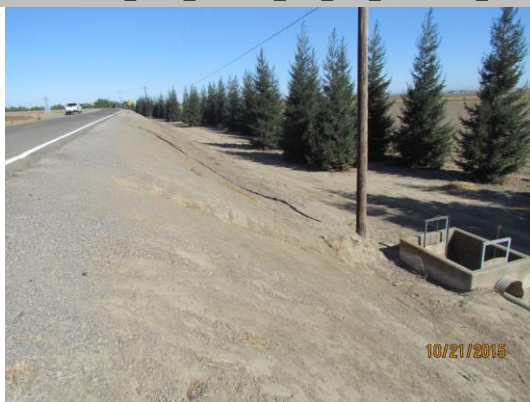
Photo 1 of 3 : FA_2016_RD1500_189_114_20160913_00058.jpg

LM Start	11.45	Rating **	M	Issue No.	114
LM End	11.45	Issue Type +	En	Location *	LS
Category	Earthen Levee			GPS Latitude/Longitude	
				Start	End
Item	Encroachments			38.868577 °	38.868577 °
				-121.746487 °	-121.746487 °
DWR ID	DWR_RD1500_01_f_2015_114				
Comment Code					
ST : Stairway					
Inspector Comment					
There is erosion at the toe of the levee where the concrete box is located.

Perspective view of the concrete box on the landward side of the levee looking upstream. Fall 2015.

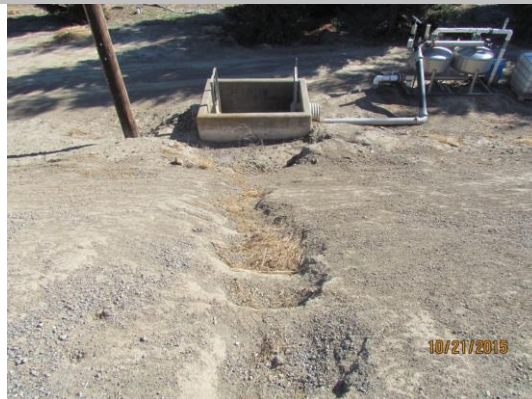
Photo 2 of 3 : FA_2016_RD1500_189_114_20160913_00059.jpg

There is erosion at the levee toe around the concrete box. There are also stairs leading down the slope. Fall 2015.

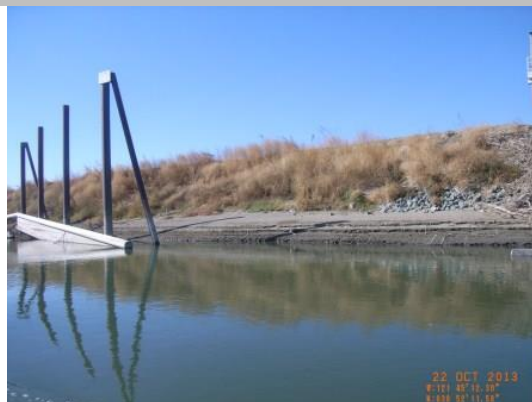
Photo 1 of 1 : FA_2016_RD1500_189_1_20160913_00001.jpg

LM Start	11.99	Rating **	A/W	Issue No.	1
LM End	12.26	Issue Type +	Ma	Location *	WS
Category	Supplemental			GPS Latitude/Longitude	
				Start	End
Item	2015 USACE Erosion Survey, DRAFT			38.870474 °	38.869139 °
				-121.752237 °	-121.757108 °
DWR ID	DWR_RD1500_01_s_2016_1				
Comment Code					
Inspector Comment					
2000 - Vertical Modesto Formation bank with mass failure. 2003 - Upstream end has some new bank retreat. 2004 - Upstream end is worse. 2006 - Some new erosion, mainly on the steep slope and scarps. (Pumping station is not part of the erosion site.) 2010 - Some new erosion and deposition at upstream end, definite encroachments. 2011 - Minor new erosion at the toe. 2015: Site removed, sufficient berm width. [2015 Site ID: SAC_96-2_L]

USACE 2013 Photo #1
